Paint Stripping Samples for Wythenshaw Hall

18th October 2018

Womersley's have been employed to undertake sample paint stripping to the fire damaged main hall at Wythenshaw Hall. The ornate plasterwork ceiling was damaged by a fire, on the 15th March 2016. Scheidel paint strippers have proved effective at removing both charred acrylic based paints and earlier plant oil based finishes below.

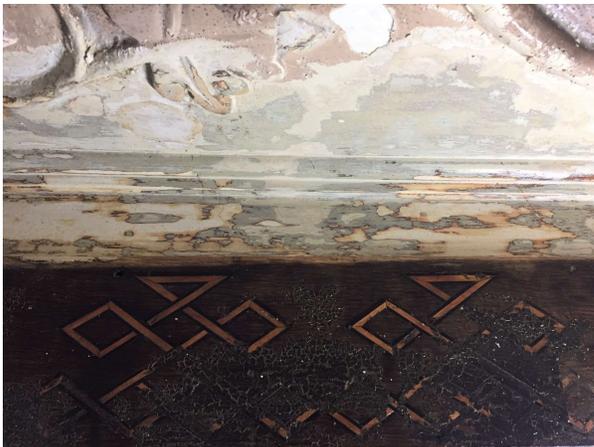
There are many types of chemical stripper with the more aggressive potions sometimes acting instantaneously while others such as the Scheidel range, applied as a poultice, pasted onto the surface breaking down the paints binders facilitating later removal by scraper or water cleaning, normally after 24 hrs.

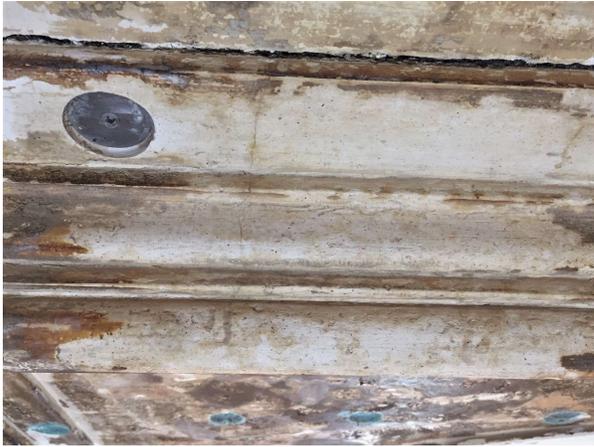
The most successful samples were stripped with a combination of Asur and SG94. Both products are CHC-free (chlorinated hydrocarbon) and work on the basis of slowly exhaling esters and other special solvents that break down the paints binders. Once the paint coatings were removed the surfaces were washed with Powerfluid and water and rinsed clean with water. Powerfluid is a detergent cleaner used after paint removal to help neutralise the chemicals.
